CHARLES RIVER DAM AT SOUTH NATICK

PHASE I INSPECTION/EVALUATION REPORT

Dam Name: Charles River Dam at South Natick

Date of Inspection: October 13, 2017

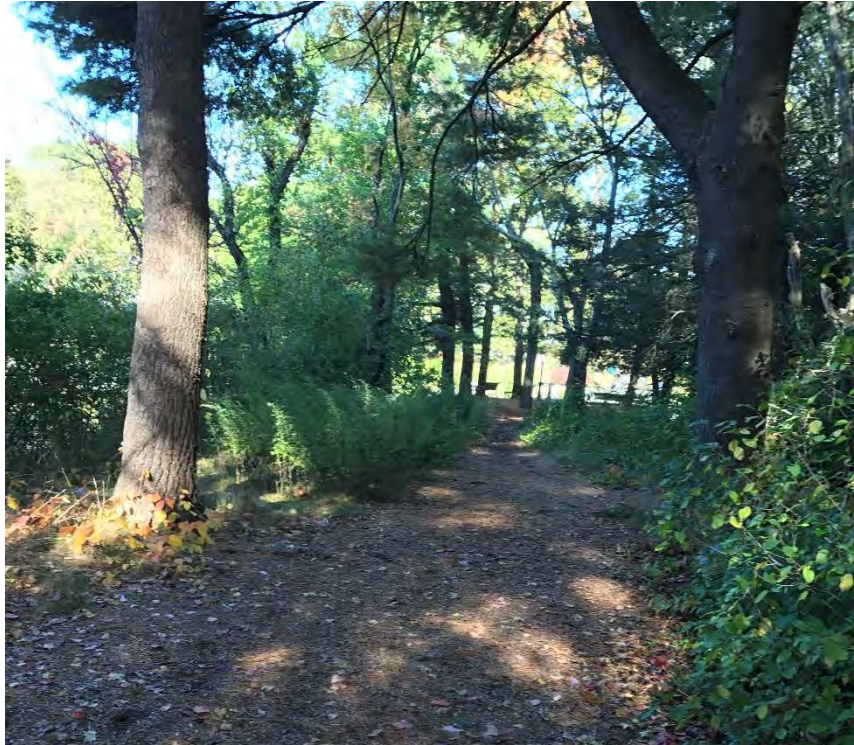
Overview along embankment crest from right abutment area. Dense vegetation at upstream and downstream sides of wood chip path obscured close inspection.

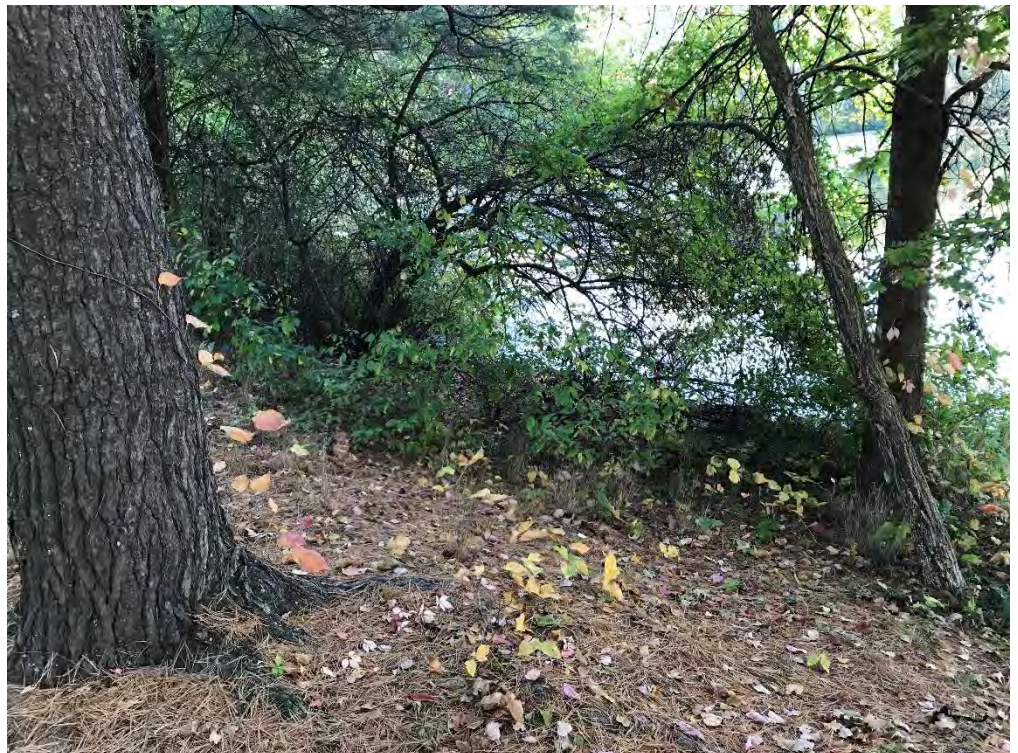
2

Closeup of upstream slope at right earthen embankment portion of dam. Note heavy overgrowth of trees and brush.

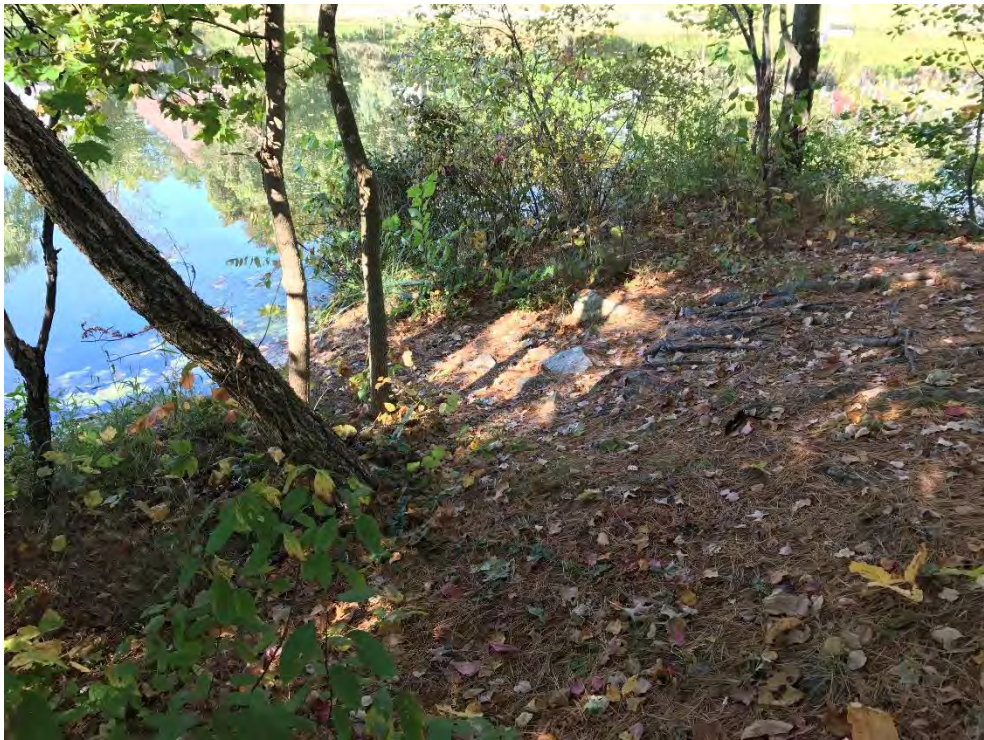
Client Name: Town of Natick, Massachusetts		Site Location: Charles River Dam at South Natick, Located Off of Pleasant Street, Natick, Massachusetts	Project No. 19114.70
Photo No. 3	Date: 10/13/2017

Direction Photo Taken: Northwest			
Description: View of erosion and exposed roots from crest leading to the water's edge on upstream embankment near the right abutment. Several similar erosion areas observed locally along upstream embankment.

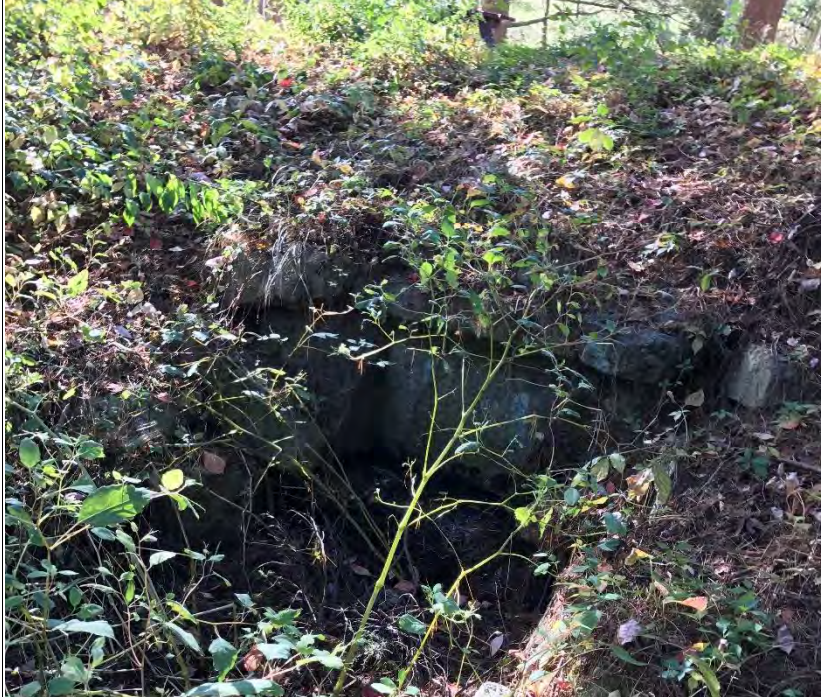
Client Name: Town of Natick, Massachusetts		Site Location: Charles River Dam at South Natick, Located Off of Pleasant Street, Natick, Massachusetts	Project No. 19114.70
Photo No. 5	Date: 10/13/2017

Direction Photo Taken: Southwest			
Description: View of former sluiceway outlet, currently plugged. Minor (less than 1 gallon per minute) clear seepage observed, similar to 2015 inspection. Seepage drains to former discharge channel immediately downstream of the toe of the earthen embankment portion.

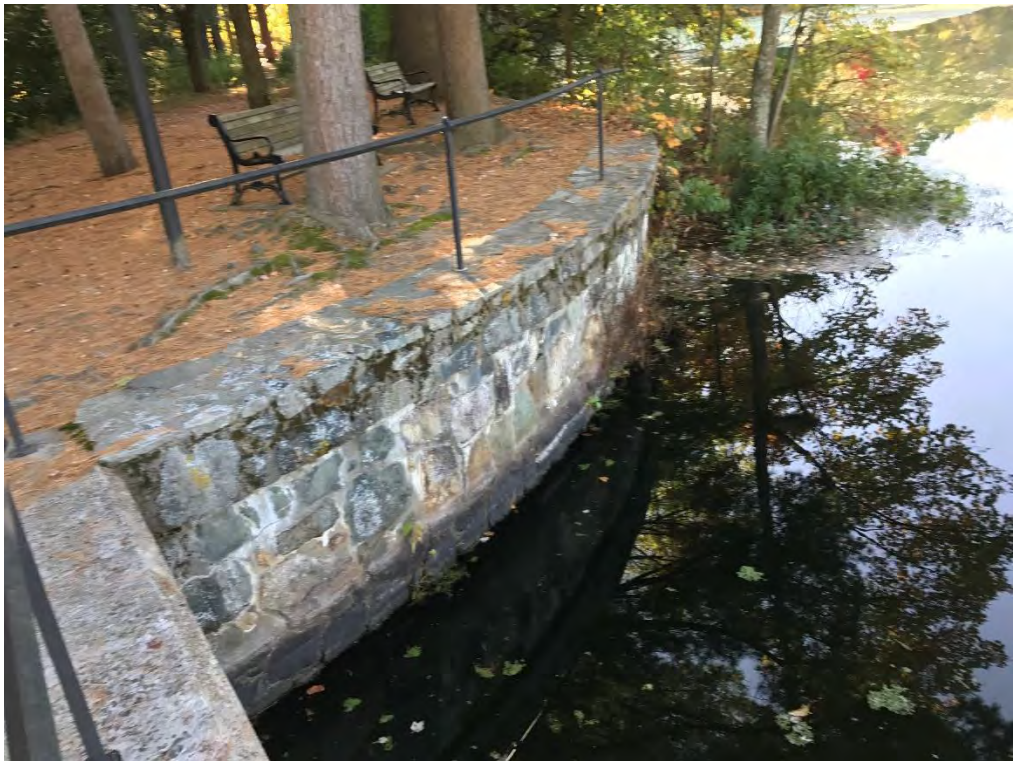
Photo No. 6	Date: 10/13/2017

Direction Photo Taken: South		
Description: View along upstream side of right spillway training wall from outlet structure.

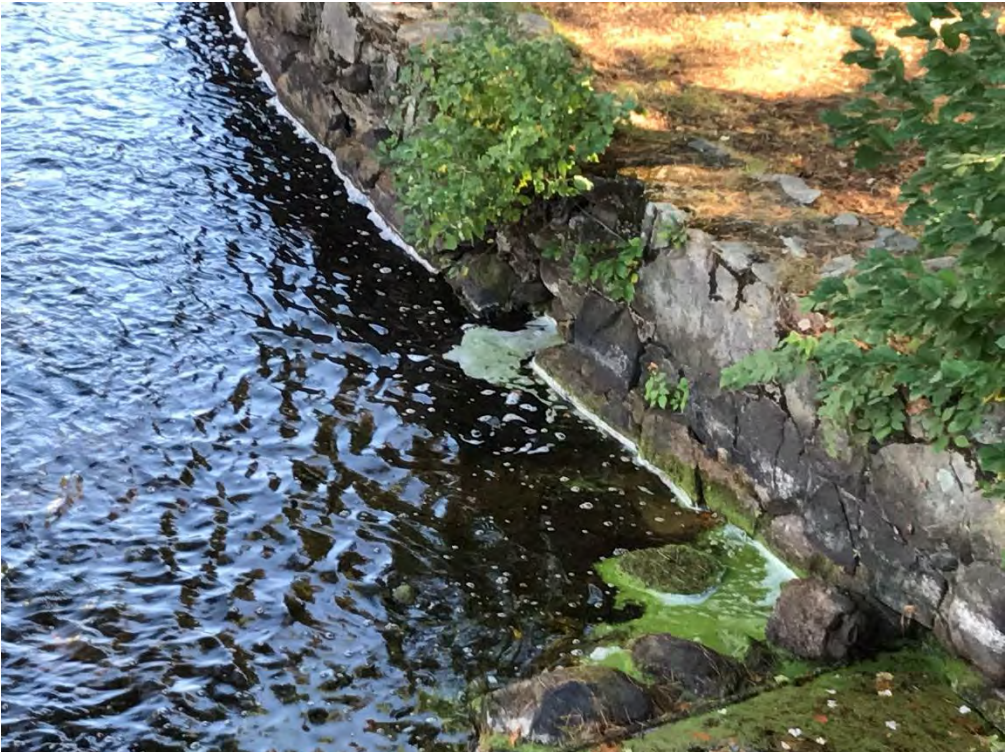
Client Name: Town of Natick, Massachusetts		Site Location: Charles River Dam at South Natick, Located Off of Pleasant Street, Natick, Massachusetts	Project No. 19114.70
Photo No. 7	Date: 10/13/2017

Direction Photo Taken: East			
Description: View along downstream side of right spillway training wall from the outlet structure. Note areas of missing stones and mortar and loss of stone.

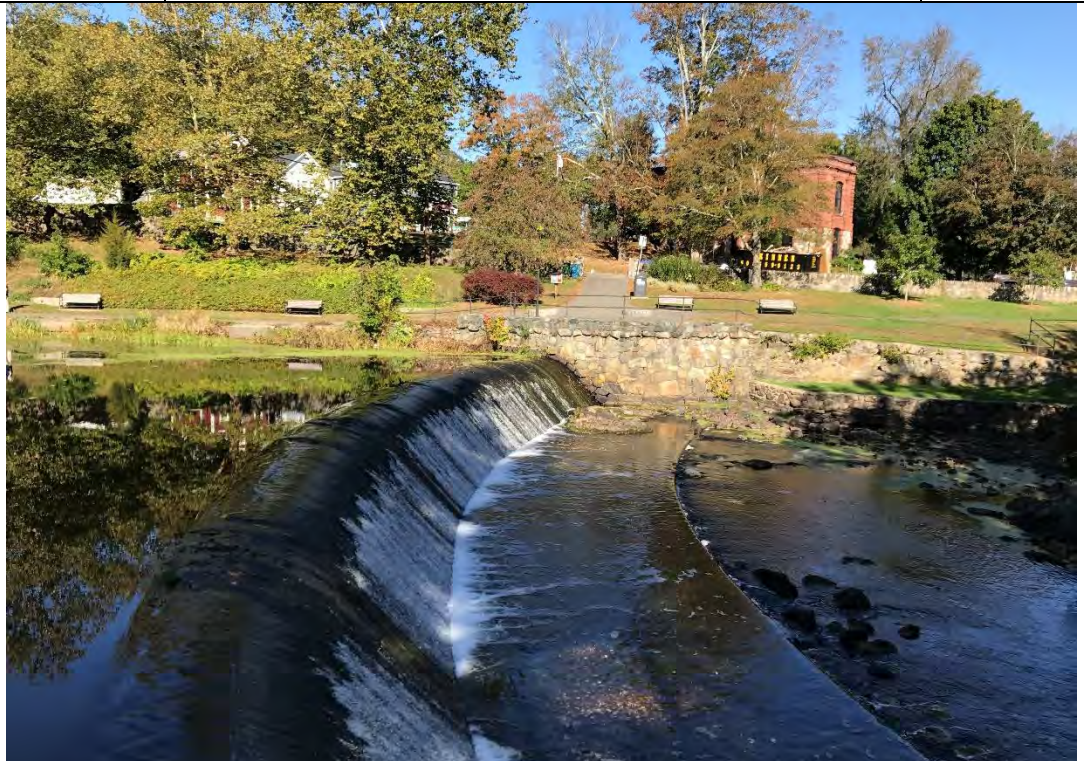
View of ogee spillway and left training wall.
Approximately 1 inch of water flowing over top of spillway during inspection.

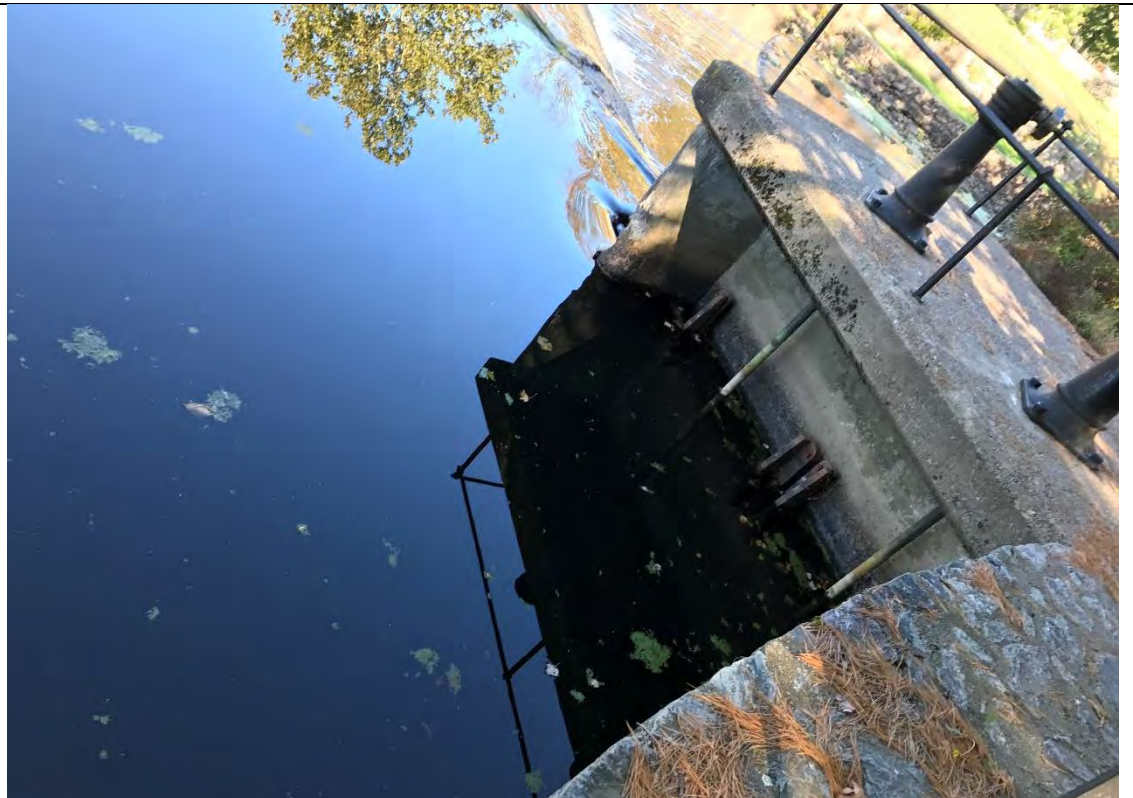
10

View of upstream side of low level outlet gates. Slide gates currently inoperable.

4. Execute a complete replacement of both gates coupled with appropriate re-configuration/restoration of the concrete superstructure surrounding the gate openings; and

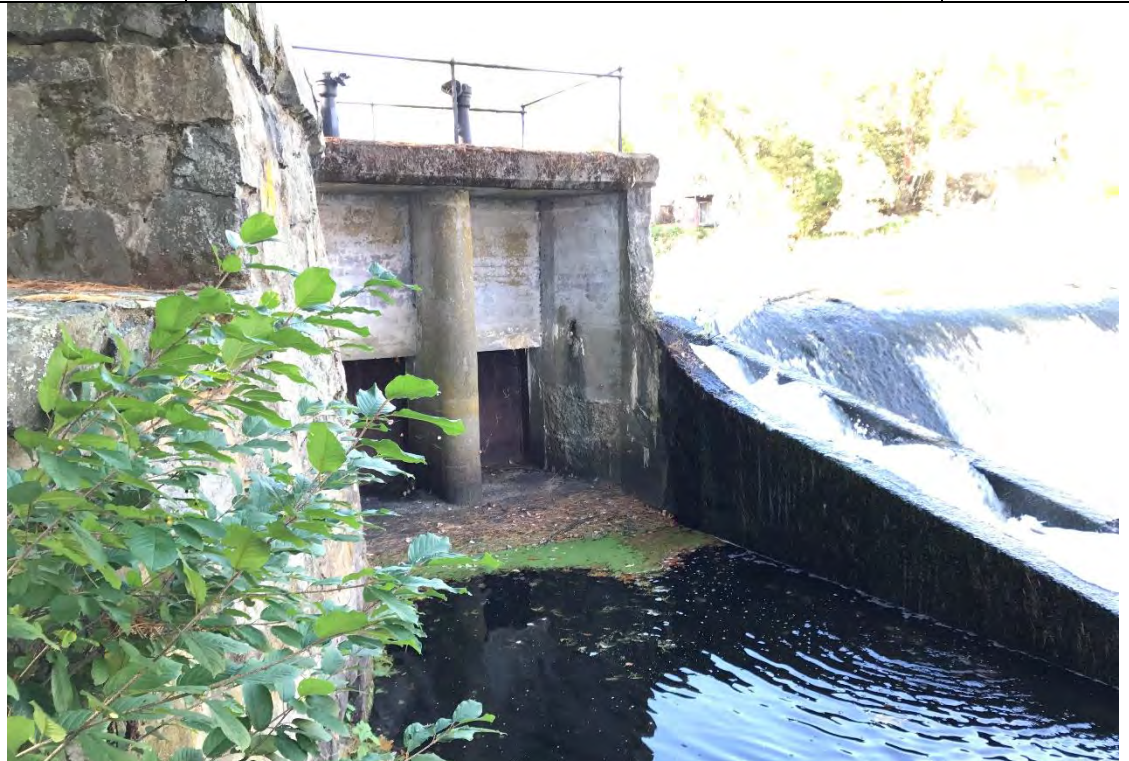
The concrete associated with the outlet structure at the right spillway abutment was generally in fair to poor condition. Concrete deterioration, chipping, spalling, efflorescence, pitting, and evidence of past minor leakage/wetness were observed at the downstream left side of the gate outlets. There was evidence of past minor leakage in the concrete wall at the downstream left side of the outlet in the form of wetness/staining. Erosion/minor void(s) were observed in the concrete along left side of outside concrete wall of outlet structure at the waterline.

View of spalled, deteriorated concrete on downstream side of outlet gate structure. Two 4' x 6' steel slide gates comprise the low-level outlet. Both gates showed no evidence of leakage, however based on diving evaluation conducted as part of 2009 Phase II study, both gates are inoperable and in need of replacement.

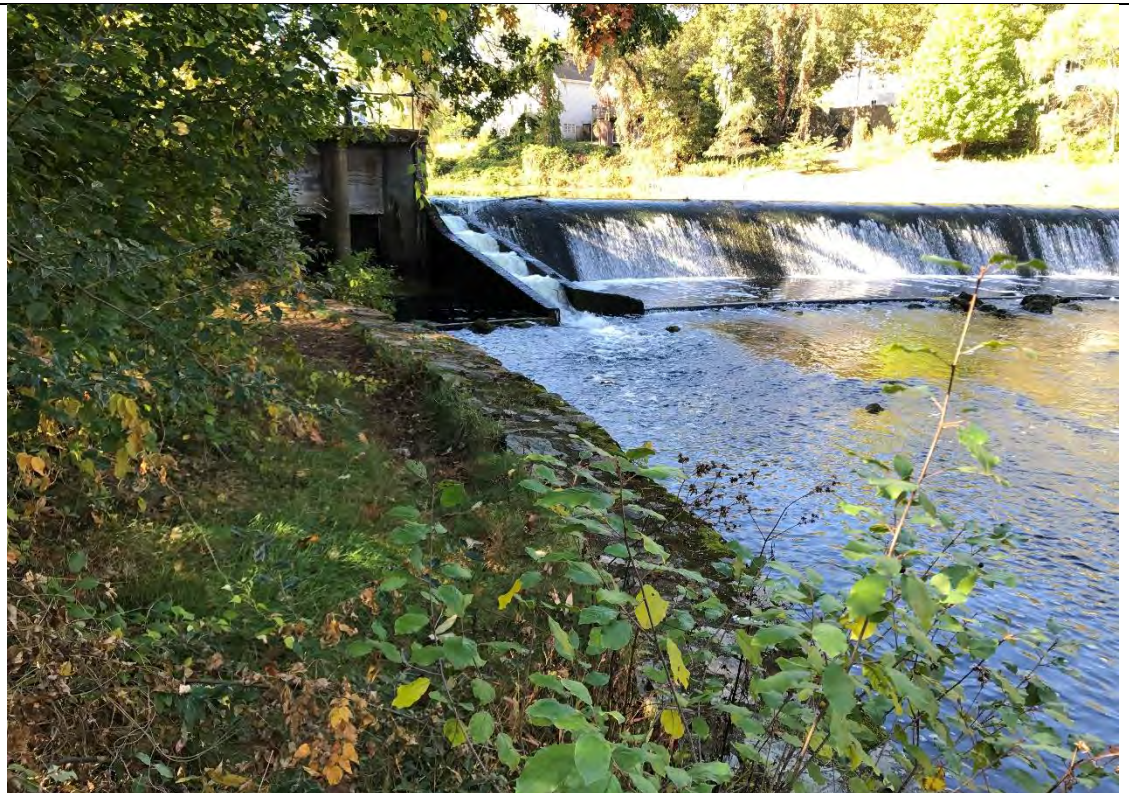
12

The low stone wall on the right side was also missing stones in localized areas and generally has a slight lean toward the river with loss of ground/ground subsidence observed immediately behind the wall. A crack was observed during the 2013 and 2015 inspections in the top of the low portion of the right training wall approximately 10 feet downstream of the high to low transition point. This crack was also observed during this inspection. A smaller top crack was observed further downstream where the right wall begins its turn parallel with the dam's axis.

View of right training wall from downstream. Note depression/loss of ground behind low training wall on downstream right side of spillway (middle ground of photo).

5. Repair/re-build the upstream and downstream training wall portions of the spillway discharge area which exhibit deteriorated concrete, missing stones/mortar, leaning and related deficiencies.

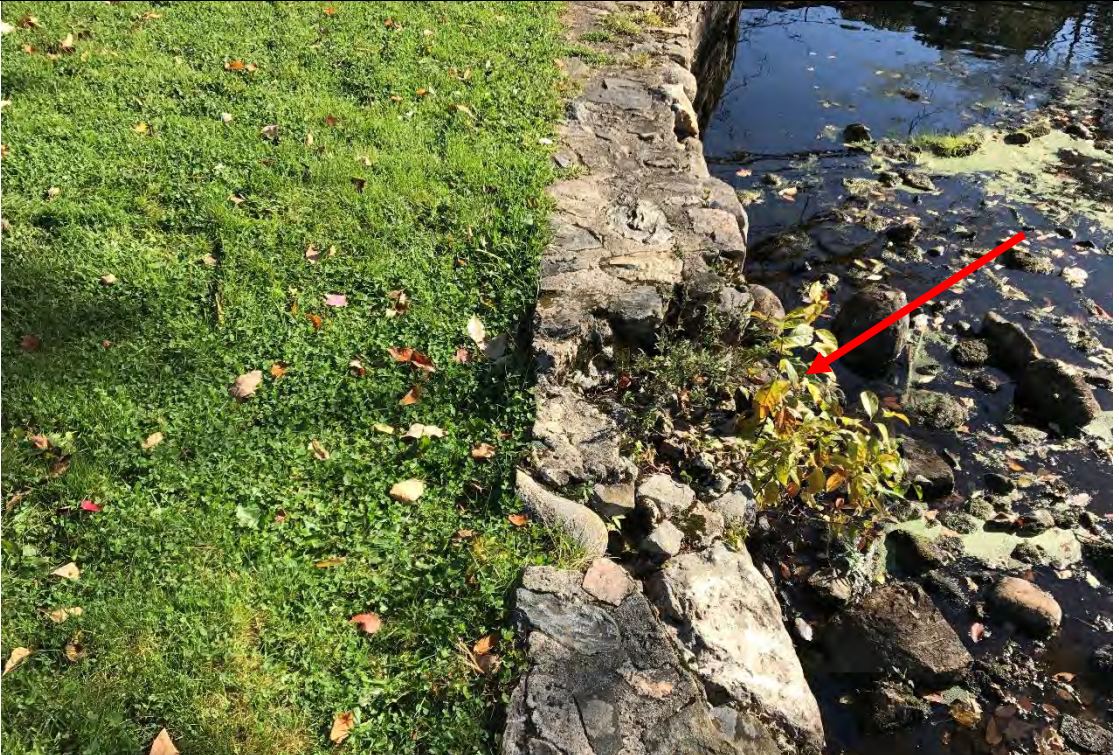
Client Name: Town of Natick, Massachusetts		Site Location: Charles River Dam at South Natick, Located Off of Pleasant Street, Natick, Massachusetts	Project No. 19114.70
Photo No. 13	Date: 10/13/2017

Direction Photo Taken: North			
Description: View of missing stones from downstream left training wall segment. Condition appears to be degraded from 2015 inspection.

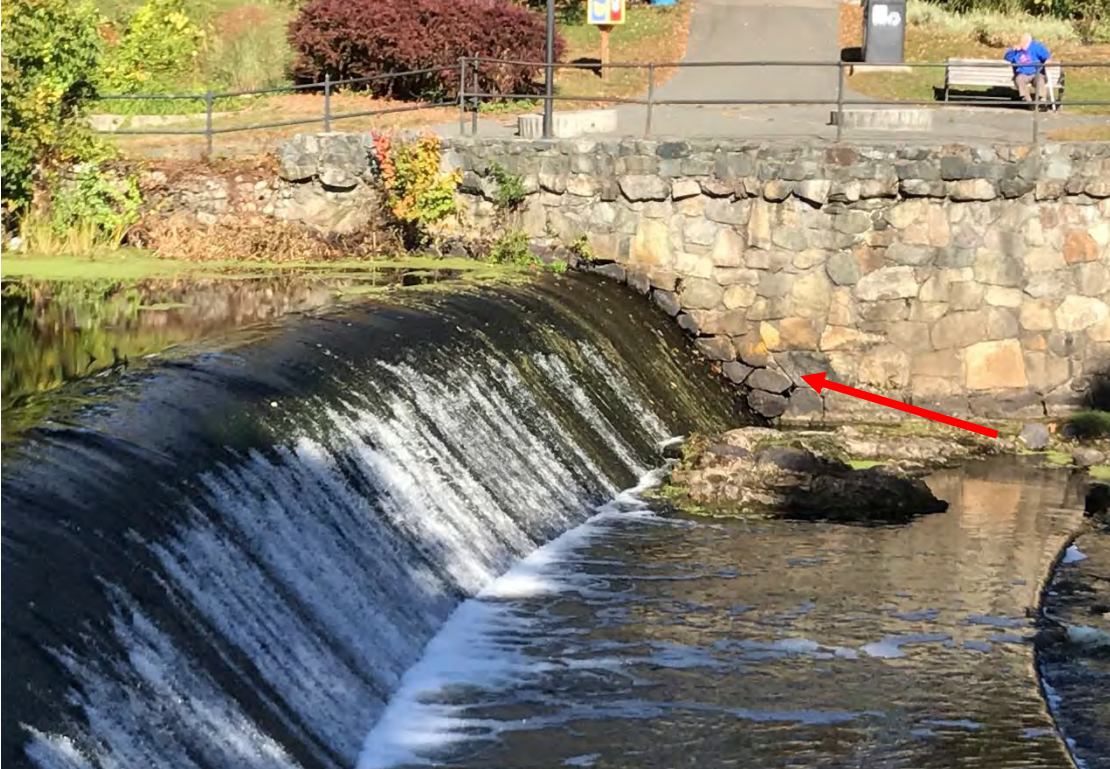
Client Name: Town of Natick, Massachusetts		Site Location: Charles River Dam at South Natick, Located Off of Pleasant Street, Natick, Massachusetts	Project No. 19114.70
Photo No. 15	Date: 10/13/2017

Direction Photo Taken: North			
Description: View of left side downstream apron and ogee spillway. Note condition of mortared stone training wall near base of ogee at left abutment where loose stones and missing mortar was observed. (See photo 16 for close up).

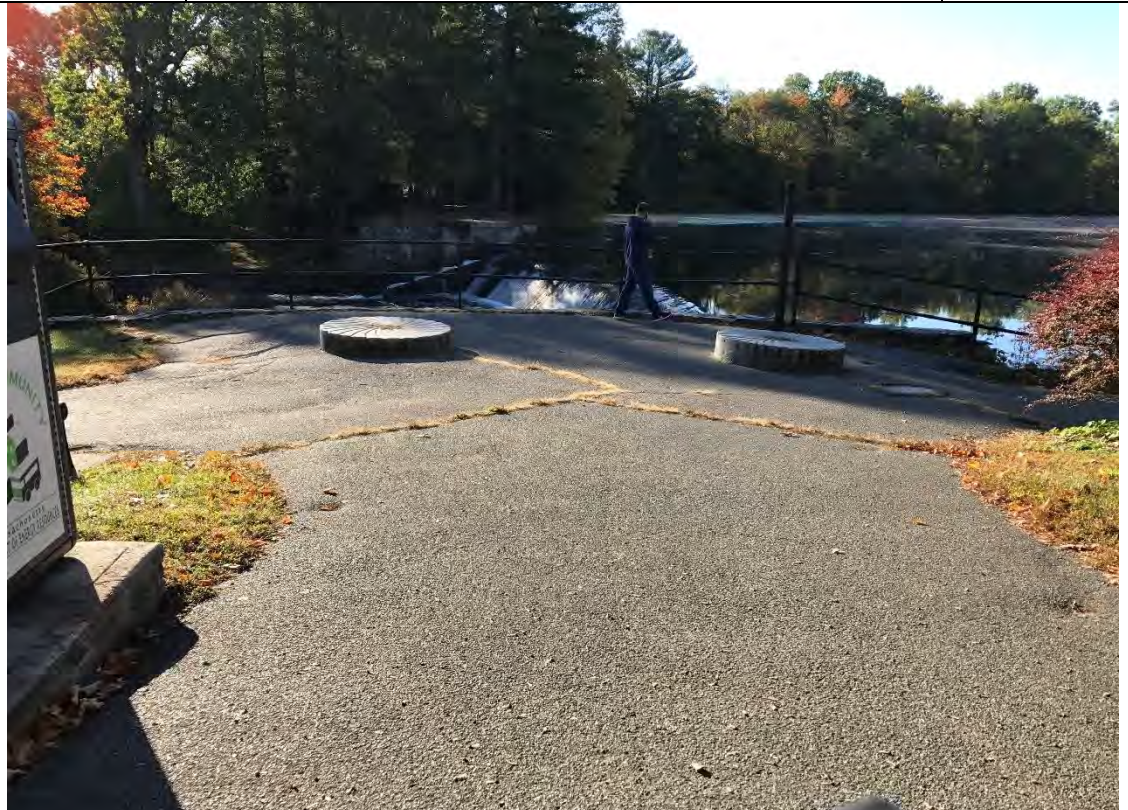
Depressions and unevenness were observed at the paved walkway behind the wall section at the spillway. Review of the FST Drawings indicates the stone masonry along this portion of the wall apparently serves is facing behind which is a reinforced concrete wall. Nevertheless this condition may be indicative of possible underlying erosion issues or loss of ground behind or through the wall in this area.

View of uneven/cracked paved walkway area behind left spillway abutment wall just downstream of ogee crest.

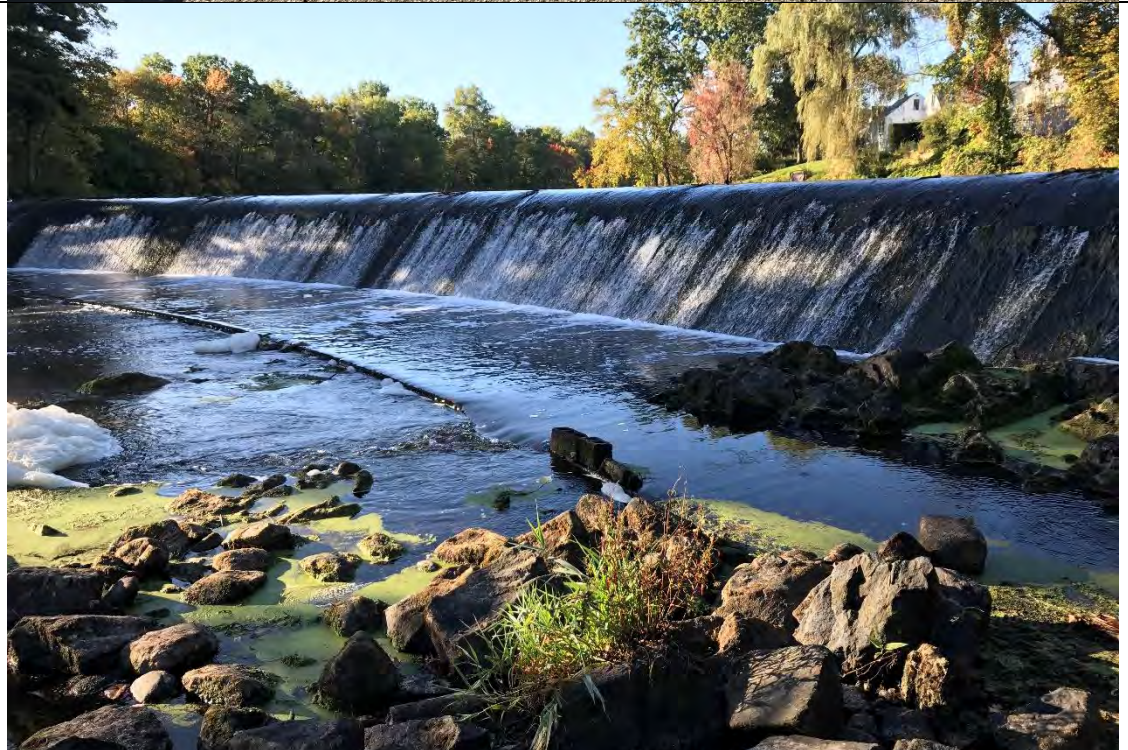
18

View of spillway apron downstream of ogee.
